Confidential Inspection Report

NOLAN
ENTERPRISE
SOLUTIONS

123 Main St., Your City, FL 12345
Inspection prepared for: Ted Sample
Date of Inspection: 5/5/2021 Time: 10:00 AM
Age of Home: 1959 Size: 1308

Inspector: Jaime Nolan
HI8017

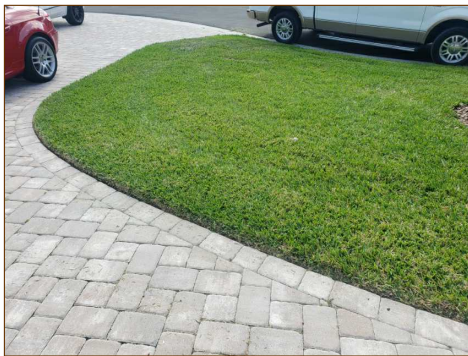
Grade at foundation appears serviceable.

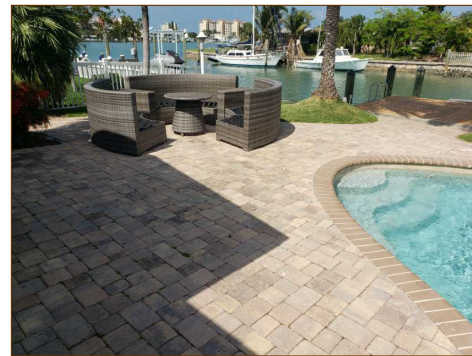
Grade at foundation appears serviceable.

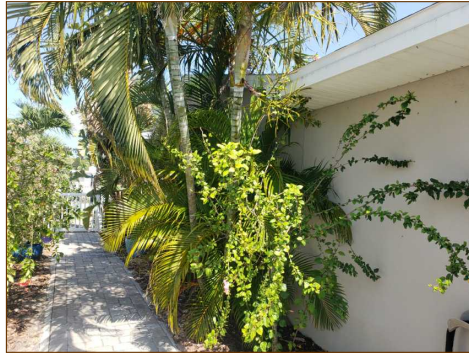
- Observations:
- Maintained overall.
 - **Minor maintenance needed.** Trim trees away from the home - Particularly at the left side of the home.

Trim bushes away from home

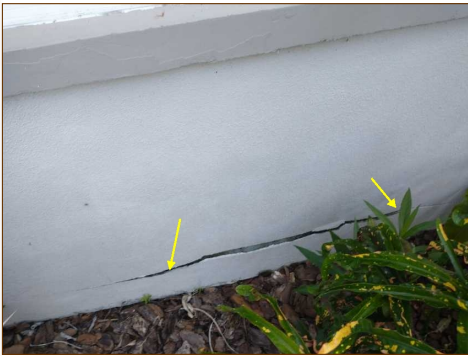
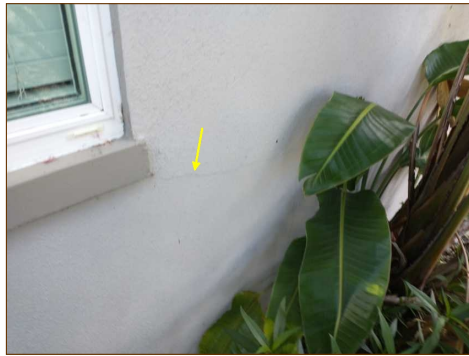
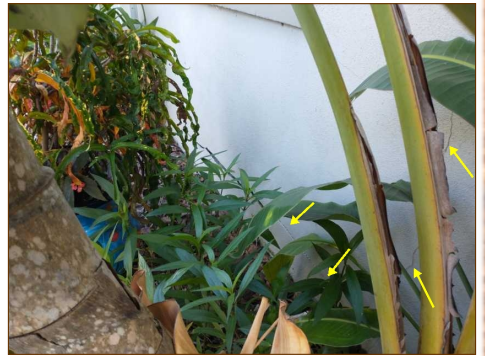
- **Damaged areas of siding are seen at the left rear corner of the home. Have a qualified stucco contractor make further specialized evaluation and minor repair as needed, preferably prior to the rainy season. Some tree removal may be needed.**

- Minor cracks are noted various areas around the home. None of the cracks appear significant. Any minor settlement or expansion cracks can be filled with a good grade of exterior rated caulk and a wet sponge used for clean-up. Where cracks are wider, they should be re-pointed with masonry.

Typical cracks

Continuation of stucco damage

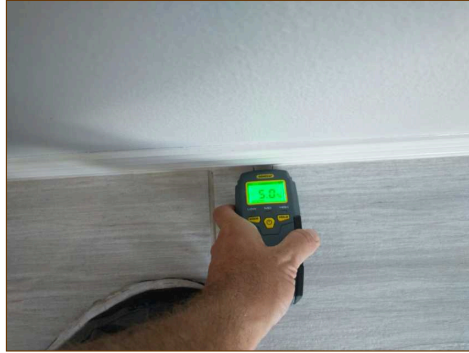
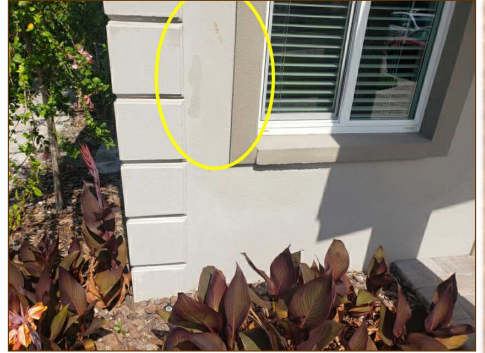
No elevated levels of moisture detected

Areas of faded paint

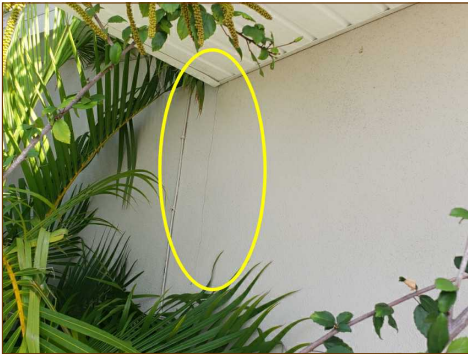
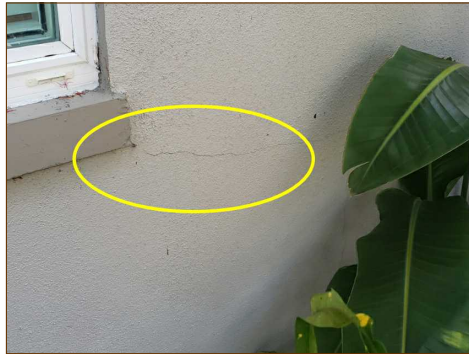
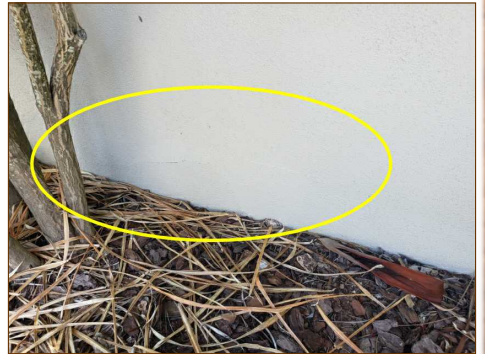
Typical crack(s)

A bit more than typical cracked stucco. It's loose.

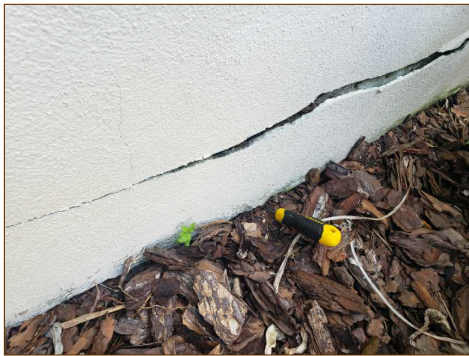
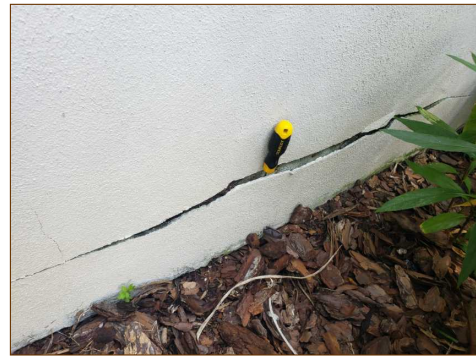
Loose stucco

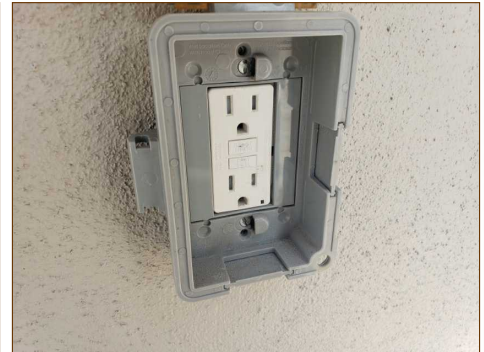
Outdoor outlets are operational and GFCI protected.

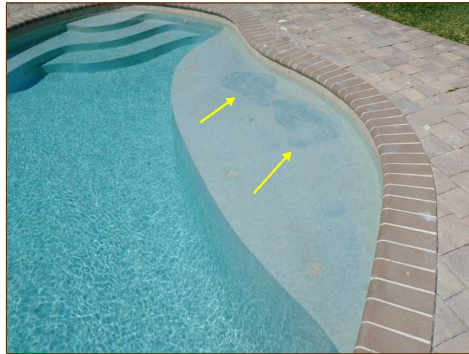
- Good overall condition.
- Cosmetic staining noted, possibly as a result of improper curing or sun exposure during or soon after installation. Simply monitor these areas for any changes in condition in the future. Proper chemical balancing is key to longevity of the pool surface.

Minor staining noted

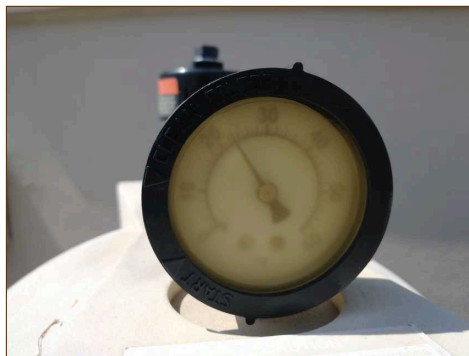
- A slightly higher than normal pressure indicates the need for filter cartridge cleaning or replacement soon.

Gauge reads about 22 psi.

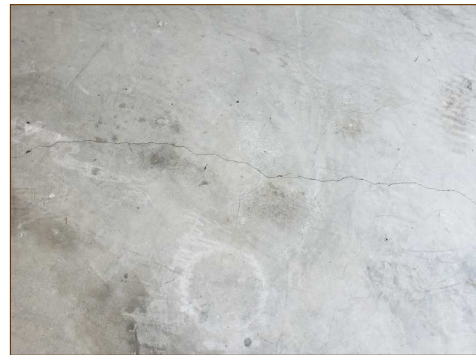
Typical crack(s)

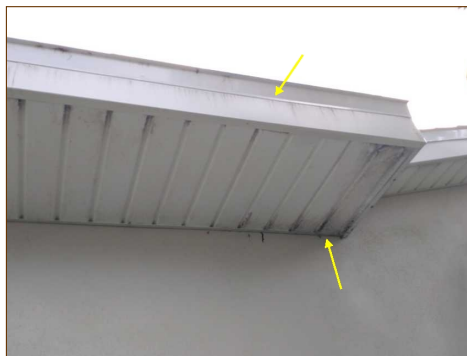
Minor staining from past leak/flattened drip edge

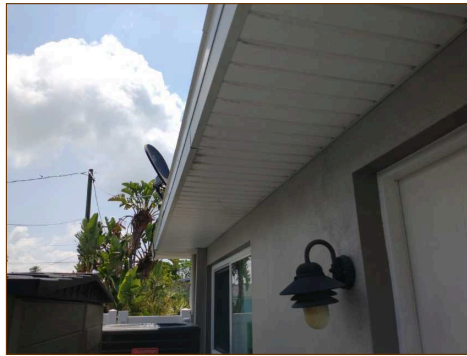
Minor moisture staining, flattened drip edge

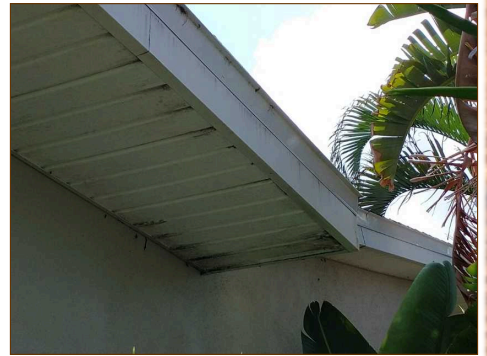
Minor moisture staining, flattened drip edge

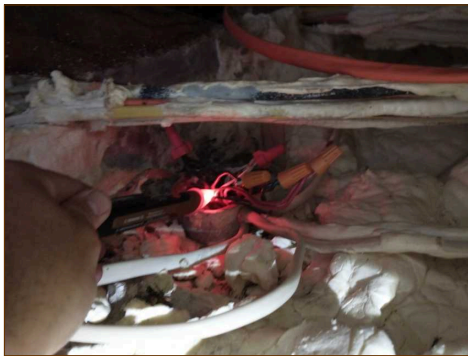
- Appears serviceable where visible.
- Some abandoned or disconnected wiring is found.
- Open junction boxes are noted about over the garage and kitchen area. Open junction boxes should simply be covered.

Open junction box over garage

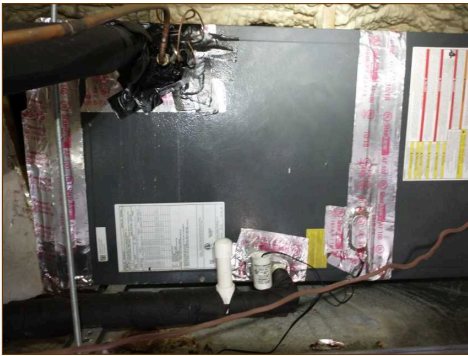
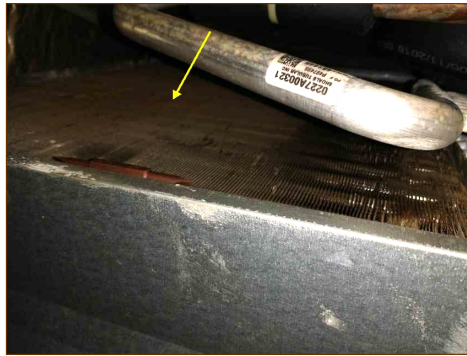
- Fan/Coil is a bit dirty. A regular maintenance type cleaning is recommended. This may help improve airflow along with ductwork improvements.
- The evaporator coil shows signs of accelerated aging, possibly due to excess heat and humidity from lack of adequate attic ventilation infiltrating the HVAC system.

View of dirty evaporator coil

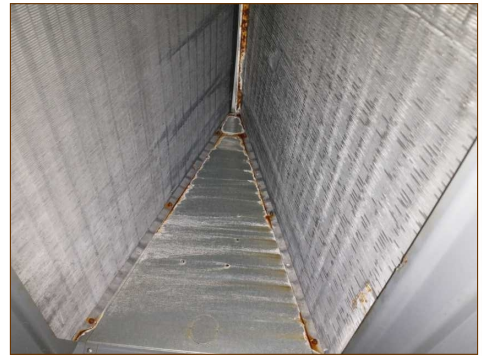
View of inside of coil, Minor accelerated wear noted

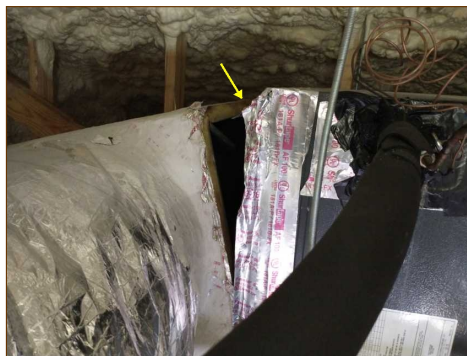
- Some sections of ductwork are not properly joined -particularly at the return.

Disconnected ductwork noted, pushed together for A/C test

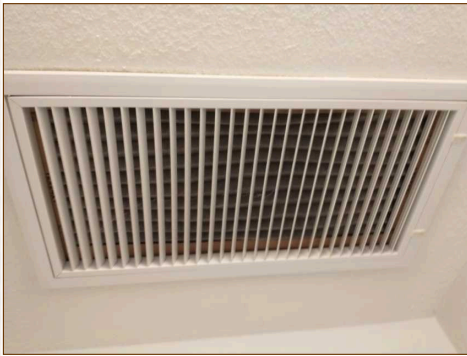
- A 12 X 24 X 1 and two 12 X 12 disposable air filters installed.
- The filter is in need of cleaning or replacement. The filters were replaced by the inspector(s) prior to running the HVAC test.

Dirty filters replaced by inspectors

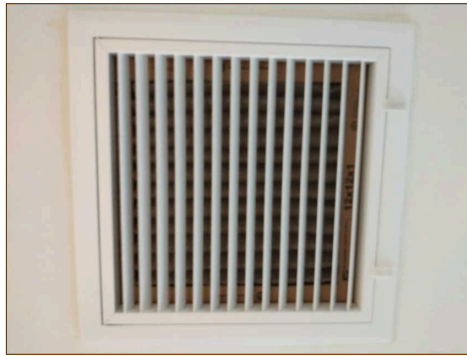
Dirty filters replaced by inspectors

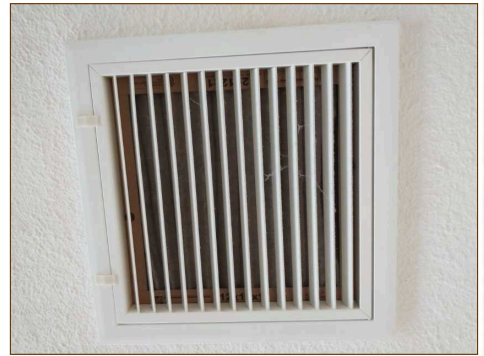
Dirty filters replaced by inspectors

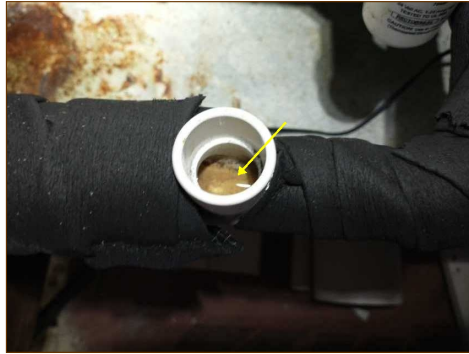
- Condensate line installed. Just a cleaning is recommended

Cleaning recommended

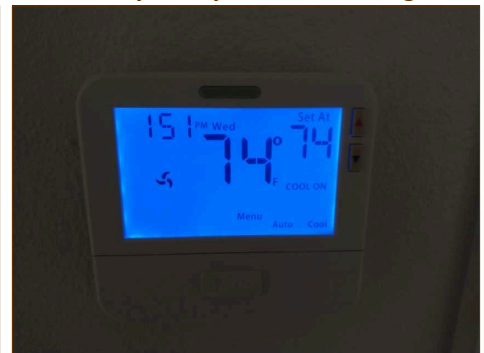
- Thermostat(s) appears to be operational. It is located in the secondary bedroom hallway.
- The thermostat never seemed to reach the target temperature and the system never shut off over the course of the inspection. This may be in part due to the lack of proper return/supply ductwork throughout the attic space and/or slight oversizing of the HVAC system(s). The system(s) may eventually bring the home to the desired temperature, however not at optimum efficiency. Elevated moisture levels are likely to be present as a result.
- Have a licensed HVAC service technician make further specialized evaluation and system design improvements as needed.

System never shut off

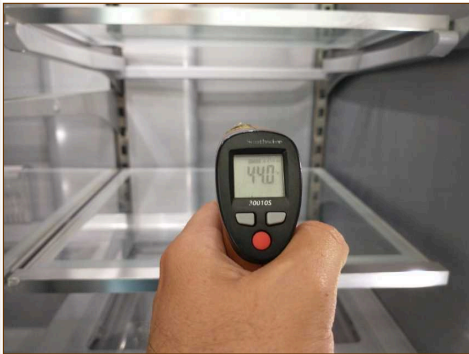
- KitchenAid
- Electric - The Refrigerator temperature is about 44 degrees and the freezer is about 10 degrees. The coldest settings of -5 and 35 are set, however for the freezer and refrigerator respectively.
- Refrigerator shows signs of past leakage. Make an inquiry regarding operation. It looks as though the refrigerator in the laundry is being used instead.
- The ice dispenser is not working. Water dispenser operated briefly, however water may be shut off behind the refrigerator. Loose handles suggest the refrigerator has been pulled out/moved in the past. Make an inquiry with the seller regarding the refrigerator. The need for a new filter may also be preventing the water dispensing functions from operating as intended.

Refrigerator temperature

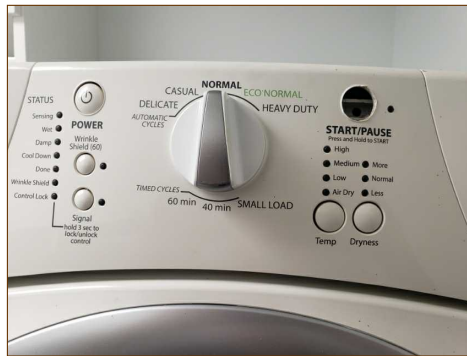
- Whirlpool
 - Electric model
 - There is only a 240-volt outlet provided for an electric dryer. If you intend to use a gas clothes dryer, you will need to have a gas line installed.
 - Dryer was not operated at the time of inspection.
 - Appliance is an older model. Unit is nearing the end of its useful life.
 - A licensed appliance repair technician should be called to make further evaluation as needed. Repair or replacement is needed.
- The circuit breaker for the dryer is turned off. Seller most likely is aware of this condition.

Inoperable "Start" button

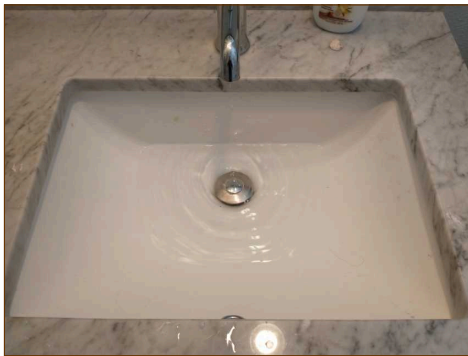
- Sink appears serviceable. Counters/cabinets appear serviceable.
- The following problems were noted at the drain: Drainage is a bit slower than normal. A drain snake or liquid plumbing agent may be all that is needed.
- Flexible pipes are not recommended for use as water can be trapped in the ridges of the pipe, which can cause bacteria/mildew growth over time. Waste lines should have a smooth interior surface. Minor corrections are recommended.

Slow drain

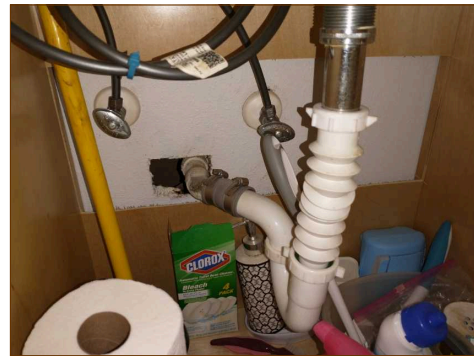
Flexible pipes not recommended

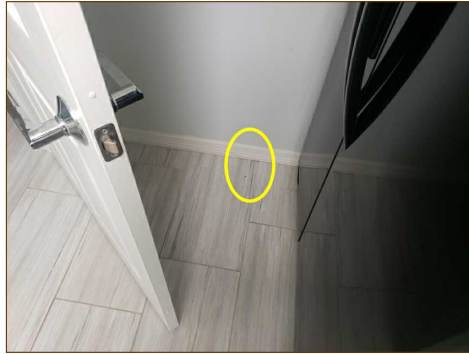
Observations:
 • As a grouping, interior doors are generally operational.
 A door stop is needed but be sure it is not installed in front of the refrigerator.
 • Some missing door stops were noted. Simply replace as needed to prevent damage to walls - particularly in the laundry room. Note: A hinge door stop is needed to allow refrigerator to still roll out.

Missing door stop(s)

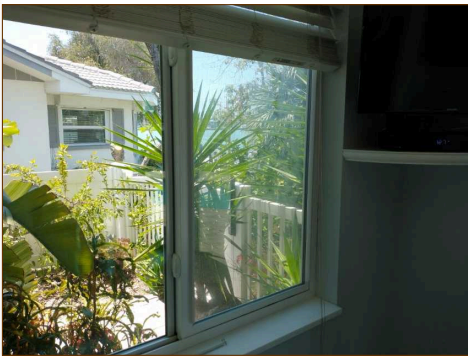
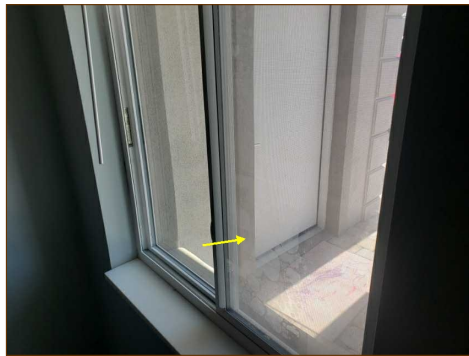
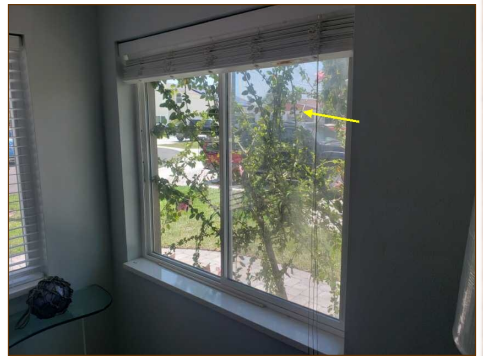
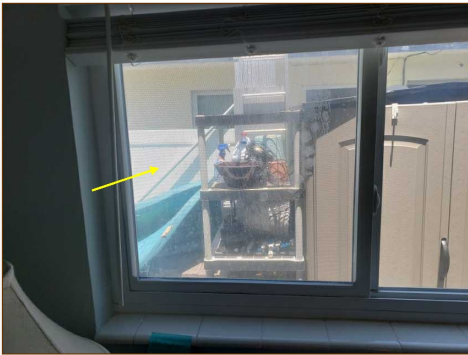
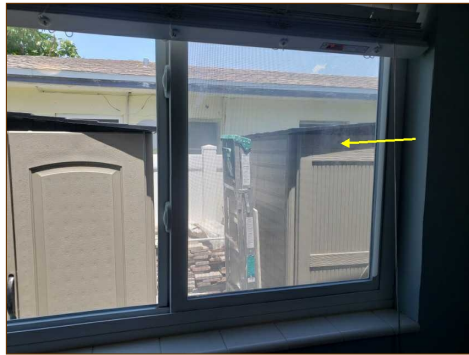
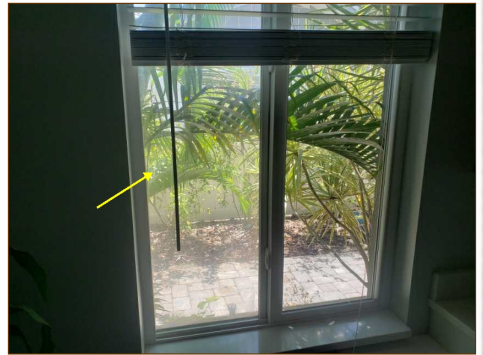
- Clad-Metal/Vinyl.
- Insulated glass.
- Low-E glass.
- Sliding.
- A representative sampling was taken. Windows as a grouping are generally operational.
- Seal failure was noted at several glass insulated glass units - particularly in the family room, the master suite, the guest master suite, the dinette area. While is is mostly a cosmetic condition, replacement of the window sashes is the only cure.

Seal failure

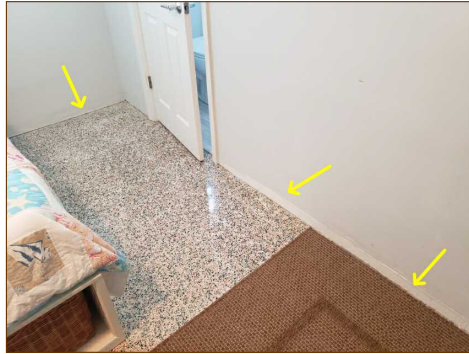
- Drywall and plaster.
- General condition appears serviceable.
- Minor repairs are needed - particularly in the guest master bedroom. The baseboards are missing

Missing baseboards

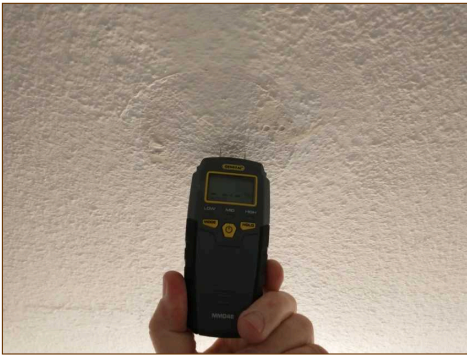
- Plaster
- Drywall
- Minor stains were noted - particularly in the bedroom hallway. No elevated moisture levels were detected.

No elevated levels of moisture detected

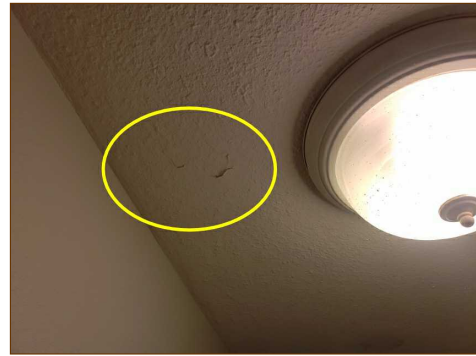
Minor damage

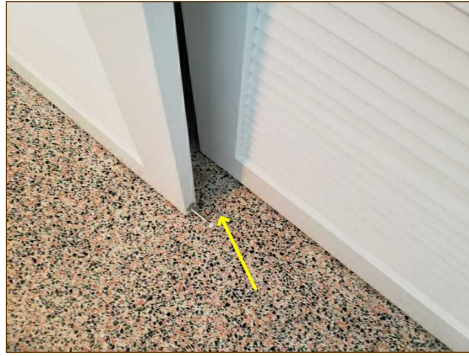
- Appear serviceable.
- Missing bottom track guides were noted - particularly in various areas throughout the home.

Missing bottom track guides in guest master bedroom

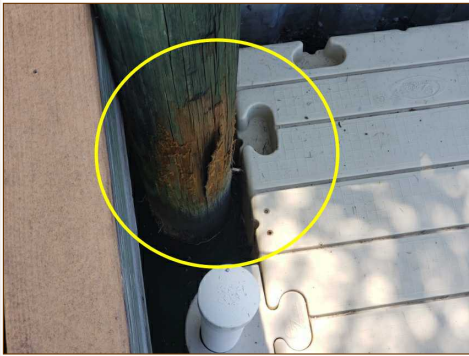
- Good
- In need of some repairs before use. Cracked pylons for the boat lift should be repaired/replaced.
- Some wood decking boards are weak and should be replaced soon.

Piling in need of some repairs before use.

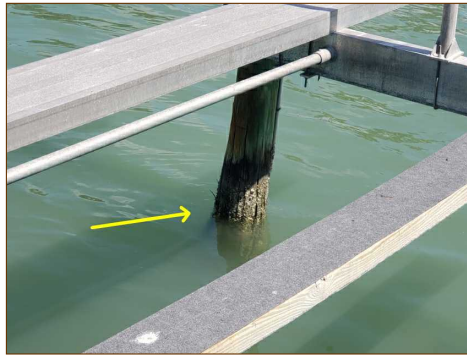
Piling in need of some repairs before use.

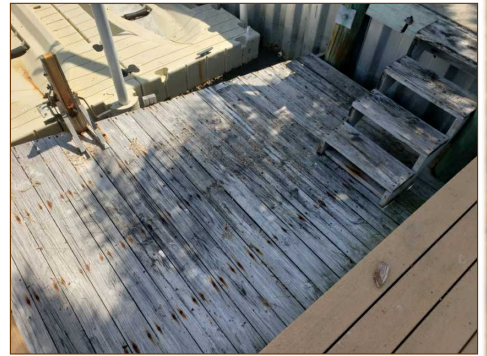
Some wood decking boards are splintered
