Confidential Inspection Report

NOLAN
ENTERPRISE
SOLUTIONS

123 Main St., Your City, FL 12345
Inspection prepared for: Ted Sample
Date of Inspection: 5/5/2021 Time: 10:00 AM
Age of Home: 1959 Size: 1308

Inspector: Jaime Nolan
HI8017

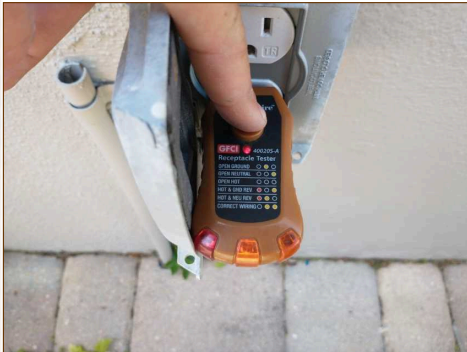
- Most outdoor electrical outlets are operational with a weatherproof cover and are **GFCI** protected.
- **GFCI is not operational at the right side of the home.**
- Have a qualified handyman make further specialized evaluation and minor repairs as needed.

No GFCI protection

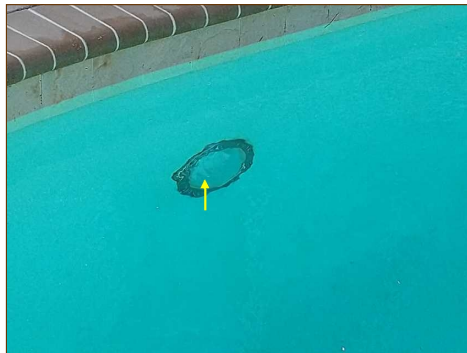
- Water in the pool light housing suggests replacement is needed.
- The pool GFCI was not located. The pool light should be GFCI protected for safety.

Water in pool light housing

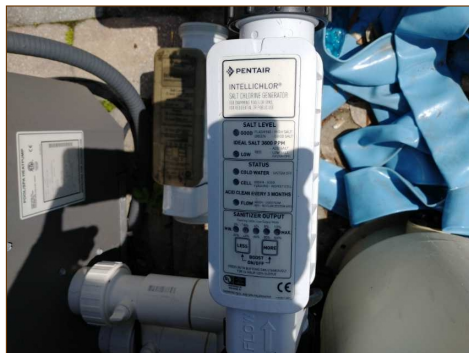
No indications illuminated on chlorine generator cell

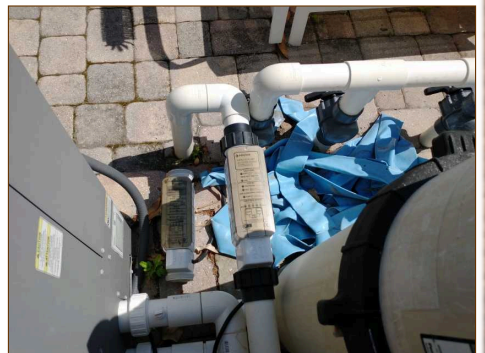
Chlorine generator cell

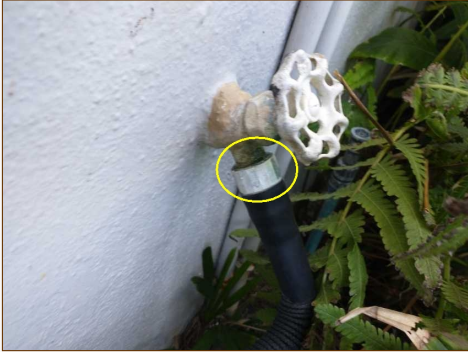
- Sample operated. No problems or concerns were observed.
- No backflow preventer(s) installed - particularly various areas around the home. Backflow preventers are an inexpensive safety device designed to eliminate the possibility of accidental siphoning of garden hose water back into the domestic water supply. They are available at most hardware or home center stores for about \$6-10.00 and simply screw onto the faucet ahead of the garden hose

No backflow preventer(s)

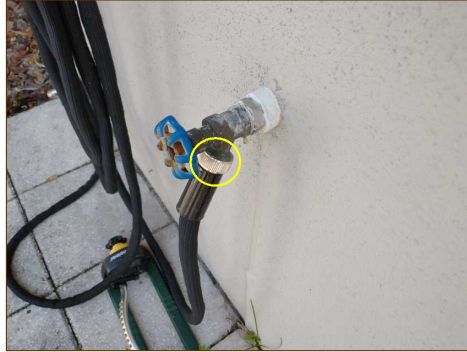
No backflow preventer(s)

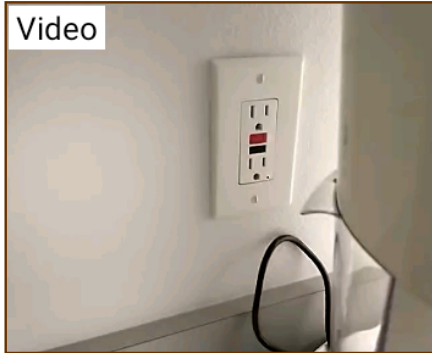
- A representative sampling of outlets was tested. As a whole, outlets throughout the house are in serviceable condition.
- **GFCI was Inoperable in the guest master suite bathroom, and the laundry room. Have a qualified electrician make minor repairs as needed. These types of upgrades are typically made when remodeling takes place.**

Inoperable GFCI outlet in laundry

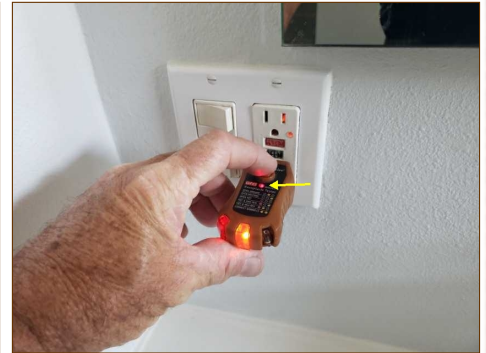
No GFCI protection in guest master suite bath

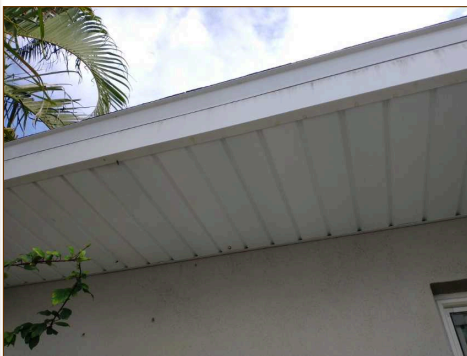
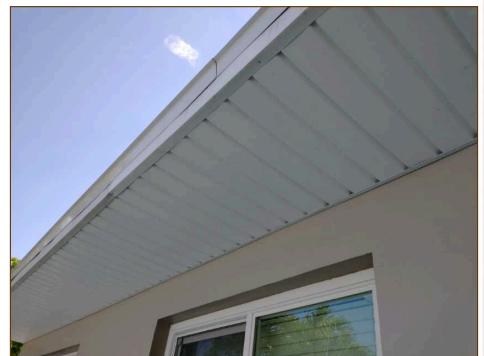
- Soffit and overhang materials are aluminum and vinyl.
- Note: Soffit areas have no venting for the attic. This roof is a sealed system.

No soffit venting

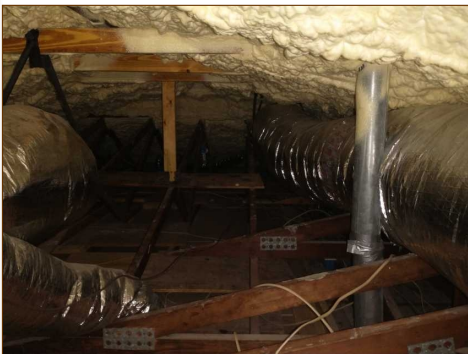
Truss framing, sheathing not visible

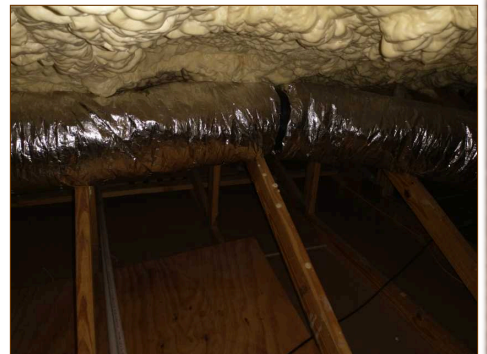
Low clearance and ductwork

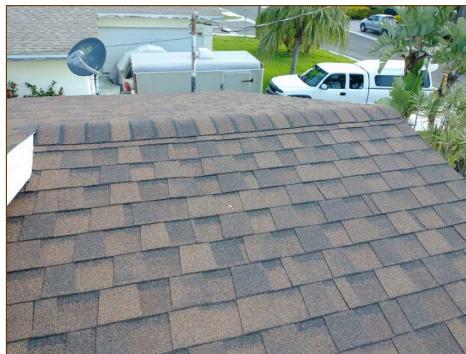
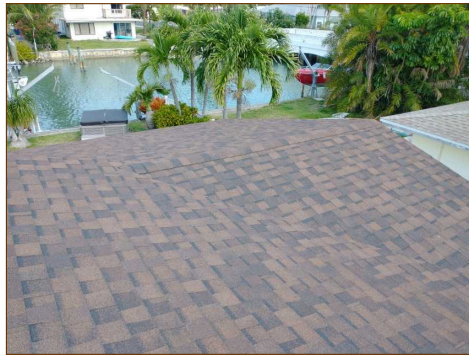
- There are no vents installed. The attic is intended to be a sealed system.

No ridge ventilation, sealed system

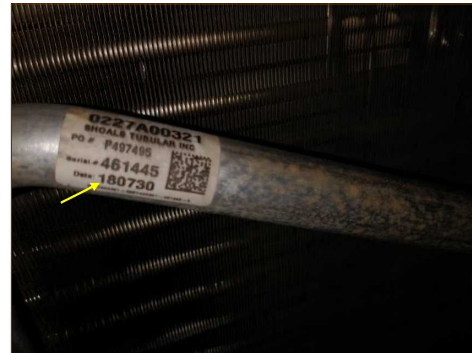
- Fan/Coil is a bit dirty. A regular maintenance type cleaning is recommended. This may help improve airflow along with ductwork improvements.
- The evaporator coil shows signs of accelerated aging, possibly due to excess heat and humidity from lack of adequate attic ventilation infiltrating the HVAC system.

Coil looks to have been replaced in 2018

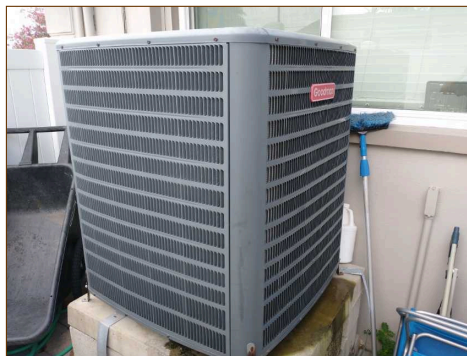
Outdoor condenser unit

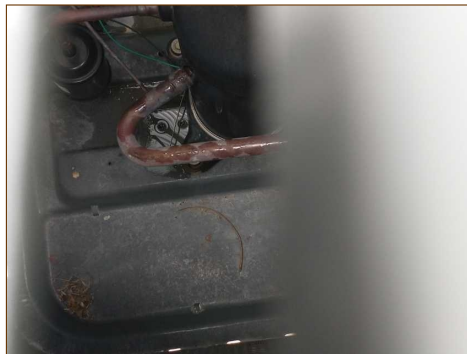
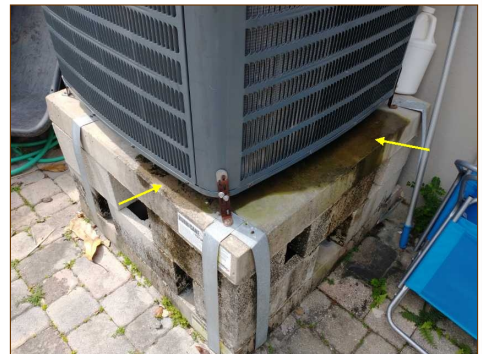
- Excess condensation is typically a sign of low refrigerant. An adequate temperature differential was noted suggesting another cause for this. This can be investigated further when the system is next serviced.

Excess condensation within unit during operation

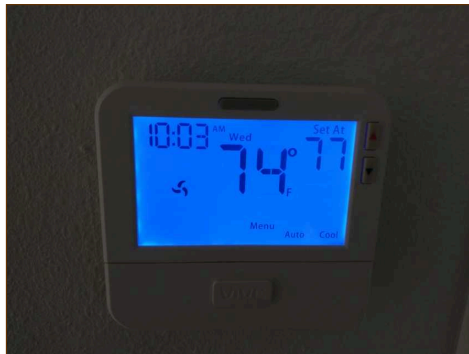
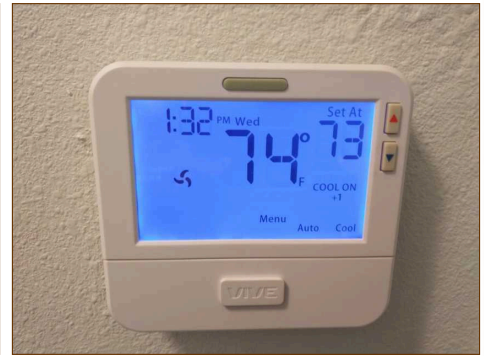
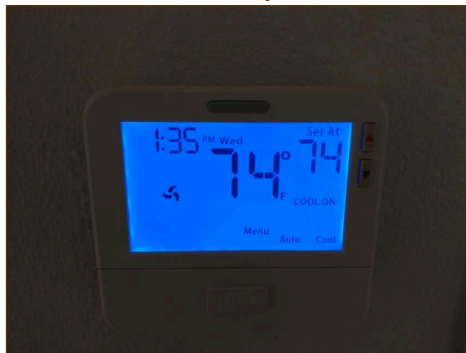
- Thermostat(s) appears to be operational. It is located in the secondary bedroom hallway.
- The thermostat never seemed to reach the target temperature and the system never shut off over the course of the inspection. This may be in part due to the lack of proper return/supply ductwork throughout the attic space and/or slight oversizing of the HVAC system(s). The system(s) may eventually bring the home to the desired temperature, however not at optimum efficiency. Elevated moisture levels are likely to be present as a result.
- Have a licensed HVAC service technician make further specialized evaluation and system design improvements as needed.

Check in, temperature dropping very slowly and system still running

Left at 74 as found, system still running

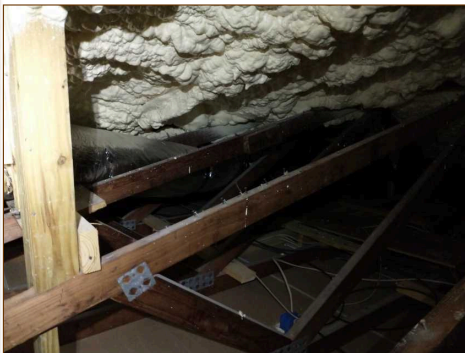
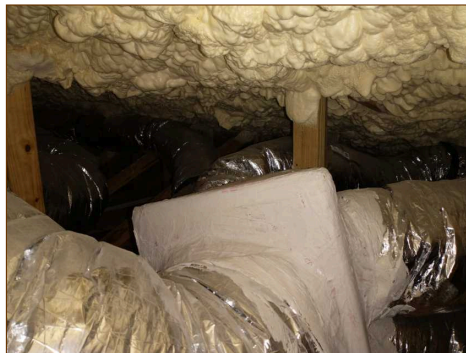
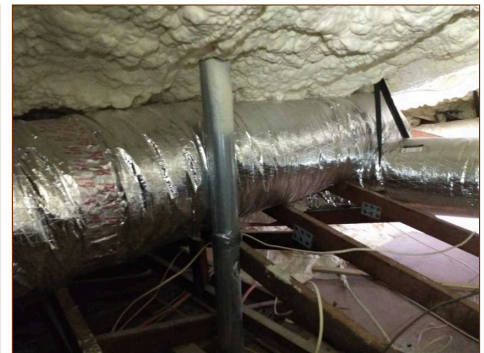
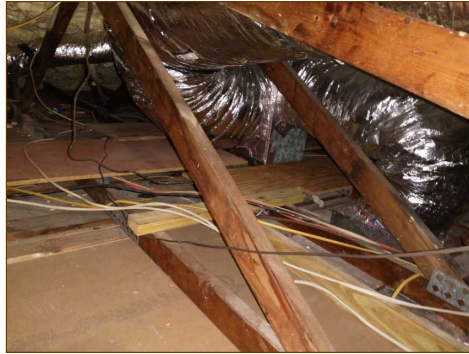
- Fiberglass Ductboard
- Flexible Round
- Ductwork is loose or disconnected - particularly over the garage. This may have been an attempt to remove heat from the attic space in lieu of proper return/supply ductwork.
- Note: No return/supply ductwork is installed in the sealed attic space. This may be contributing to elevated moisture levels in the home at certain times of the year and accelerated wear of the HVAC system evaporator coil. The coil looks to have been replaced only two years after installation. Return/supply ductwork should simply be installed to circulate the attic air as this is intended to be conditioned space.
- A licensed mechanical contractor should be called to make further analysis of the ductwork system. Given the oversizing of the system, it may even be possible to condition the garage to improve balancing and efficiency of the system.

No supply ductwork in attic space

No return ductwork in attic space

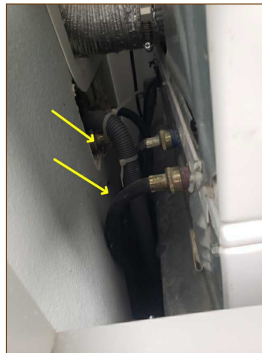
- Observations:
- Plumbing appears serviceable.
 - There is a connection box installed in the wall with both hot and cold water and a drain pipe. The drain pipe was not flood tested.
 - We recommend upgrading hoses to steel braided type.

Supply hose upgrade is recommended

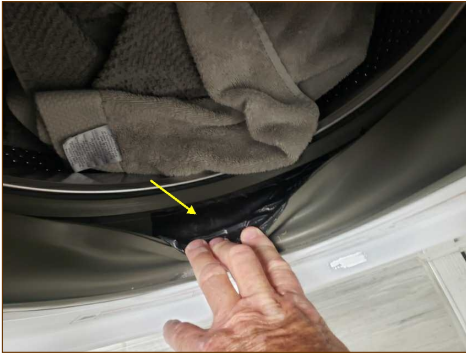
- Observations:
- Whirlpool
 - Appears serviceable/within useful life. Appears more than 10 years old.
 - Washer is an older model. Appliance is nearing the end of its useful life.
 - Washer is located at an interior area and is not provided with an emergency overflow pan. These pans with their drain lines act to prevent damage to flooring and furnishings, should the unit begin leaking. They are a good idea however, and should be installed at the time of washer replacement, provided an exterior wall through which the drain line can flow by gravity is located conveniently nearby.

Gasket repairs are present

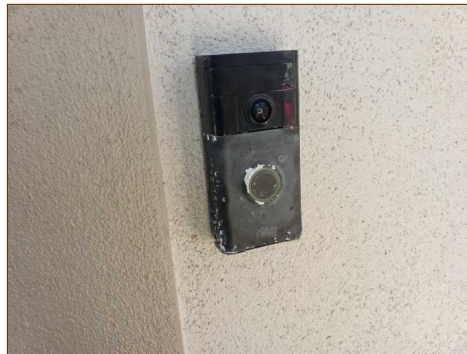
Observations:
 • Front door is composite material - Appears serviceable.
 • Hardware operational.
 • Door Bell is not operational.

Inoperable door bell

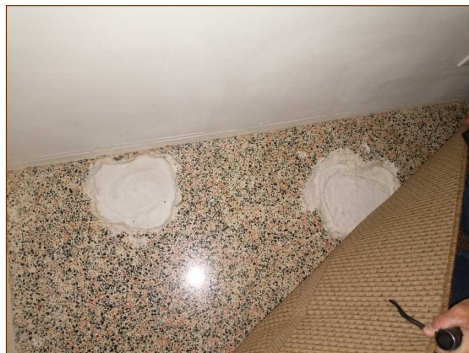
- Ceramic/porcelain tile
- Terrazzo floors
- Rugs and floor coverings prevent viewing of primary floor materials.
- Ceramic tile
- Terrazzo
- Stored items or furnishings prevent full inspection.
- Minor damage/deterioration is noted - particularly in the guest master suite.

Minor damage in 2nd bedroom

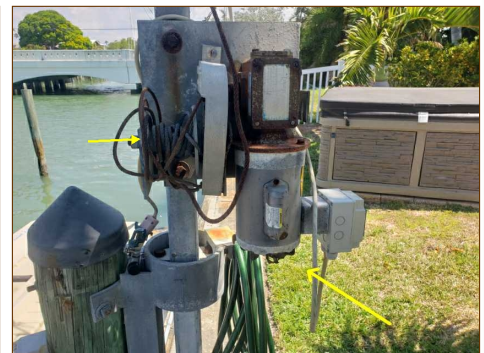
Davit lift is not operational

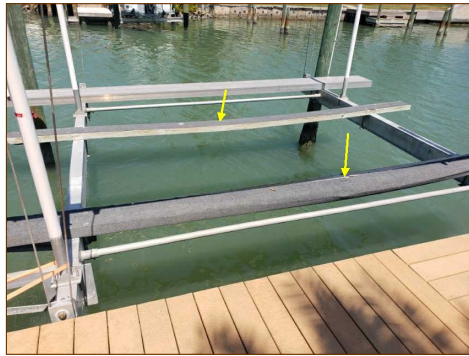
Bunks need maintenance and/or adjustment
