Confidential Inspection Report

NOLAN
ENTERPRISE
SOLUTIONS

123 Main St., Your City, FL 12345
Inspection prepared for: Ted Sample
Date of Inspection: 5/5/2021 Time: 10:00 AM
Age of Home: 1959 Size: 1308

Inspector: Jaime Nolan
HI8017

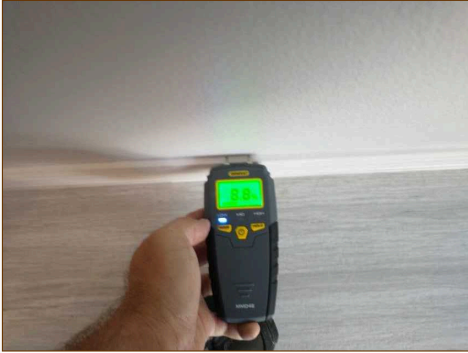
No elevated levels of moisture detected

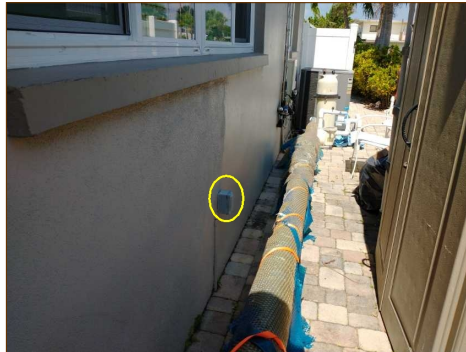
Perspective view

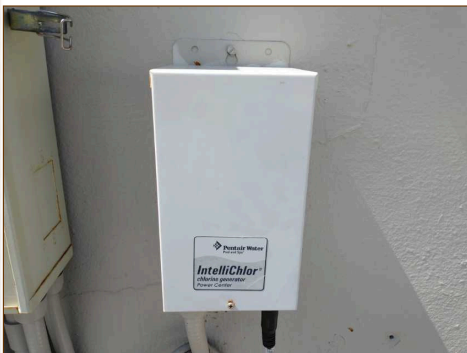
- Chlorine generator cell was not operating. Chemicals may be added manually.

Chlorine generator

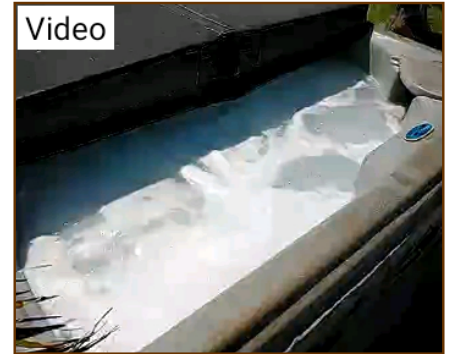
Hot tub operated

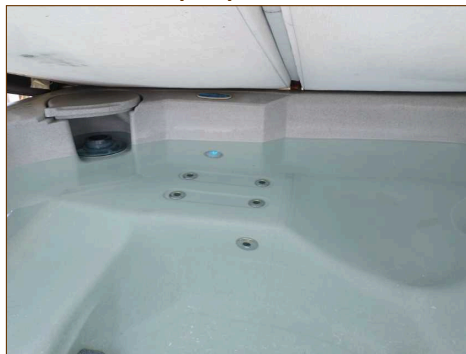
Light operated

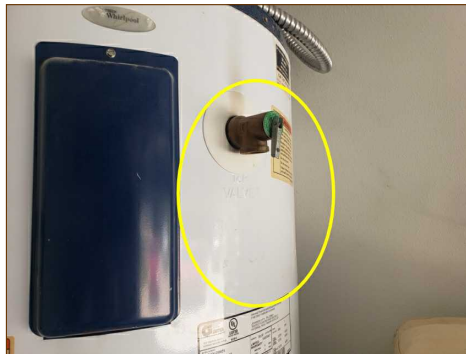
- No significant problems or concerns were observed.
- A water shutoff valve is installed
- Both electrical elements were accessed and tested for continuity. They were both found to be operational.
- **Pressure relief valve drain line is missing or ends prematurely. This is a SAFETY HAZARD. We recommend this drain line be extended to a safe location.**

Extended TPR drain line as needed

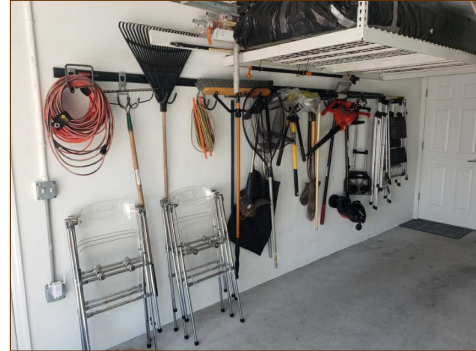
- Observations:
- Exterior walls are Concrete Block and stucco
 - Interior wall(s) is/are Drywall.
 - General condition appears serviceable.
 - **Stored items prevent viewing some areas.**

Stored items

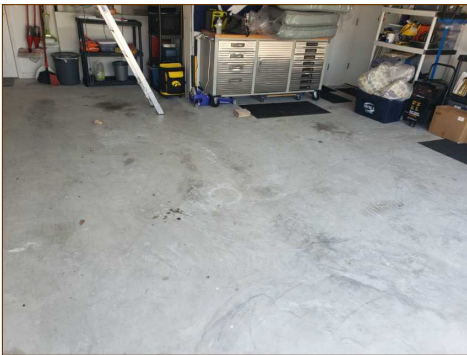
- Appears serviceable - typical cracks noted.
- Floor is not fully visible, due to stored items.

View of floor

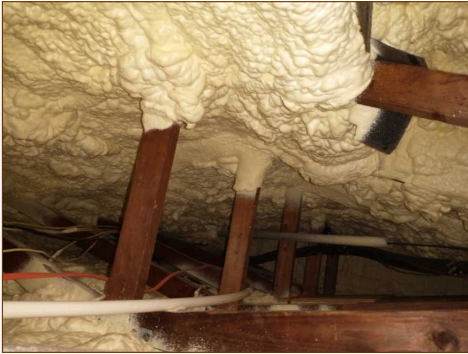
Limited view

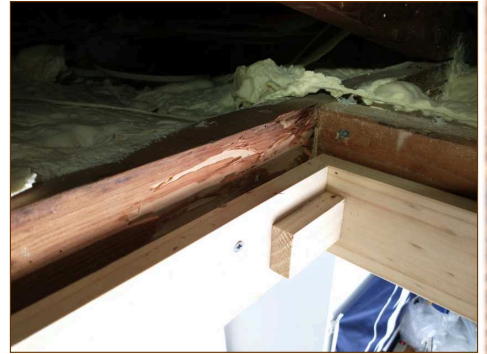
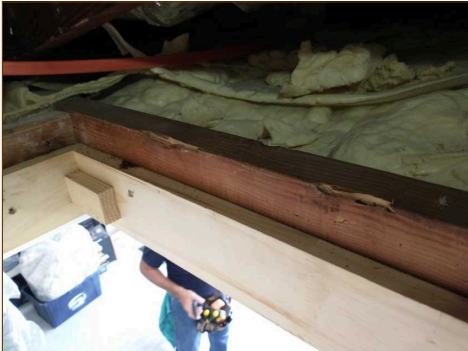
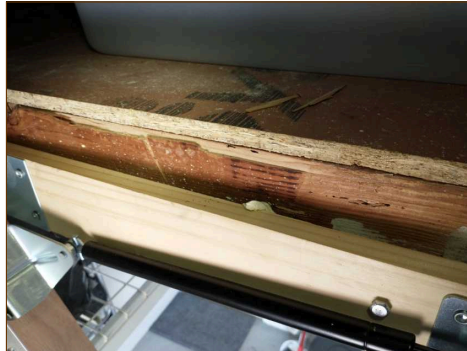
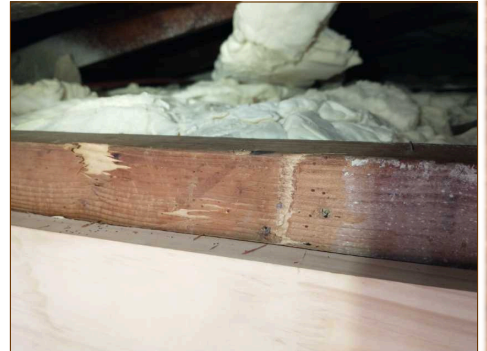
- A truss system is installed in the attic cavity that is used to support the roof decking and transmit the roof load to the exterior walls.
- The roof decking material is not fully visible due to installed insulation, however looks to be dimensional lumber and likely some 1/2" plywood sheathing. Appears in serviceable condition overall when walked on roof.
- Note: Truss alterations/repairs appear to have been made when the addition was put on. No visible problems or concerns were noted.
- Past wood eating insect activity is suspected. A licensed pest control contractor should be called to make further evaluation as needed. An inquiry should be made regarding any past treatments or bonds on the property.

Past wood eating insect activity

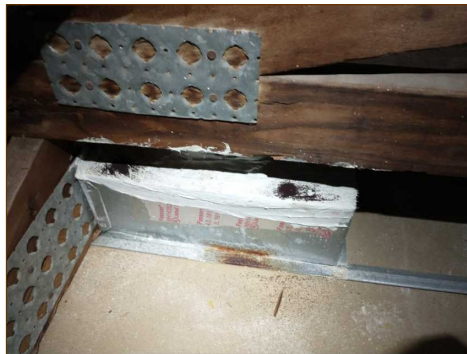
Past wood eating insect activity suspected

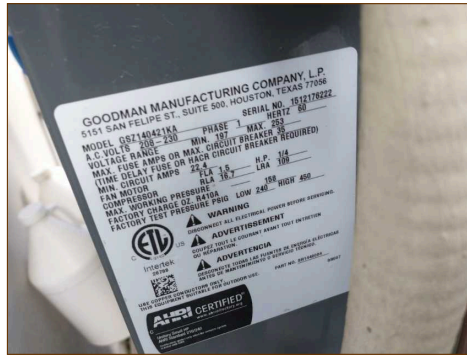
Data Label

- Manufactured in 2015, installed in 2016.
- 3.5 Tons.

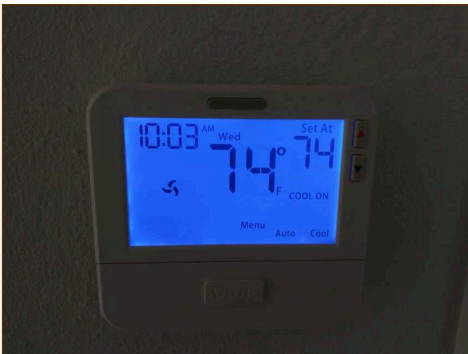
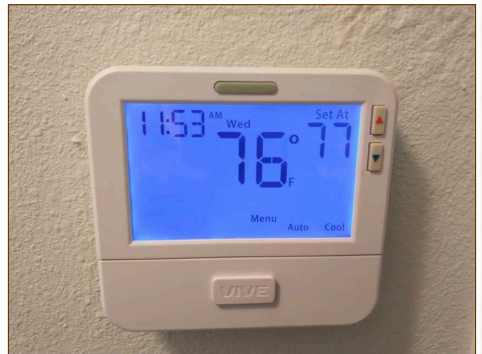
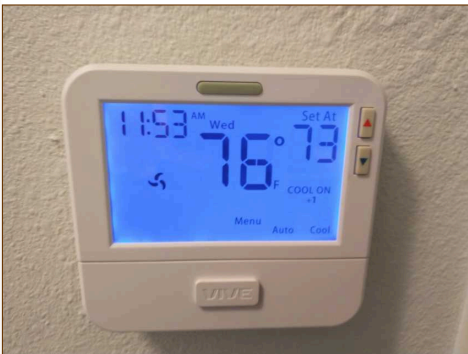
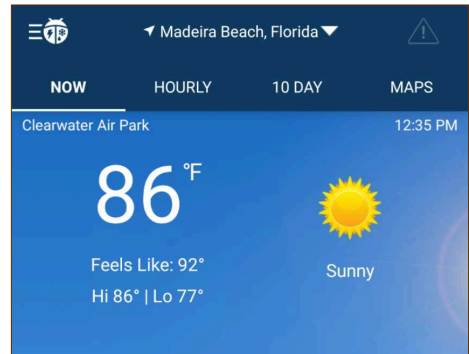
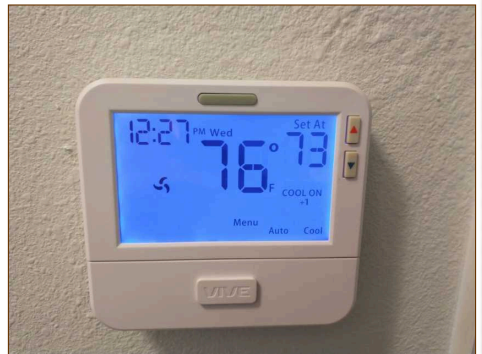
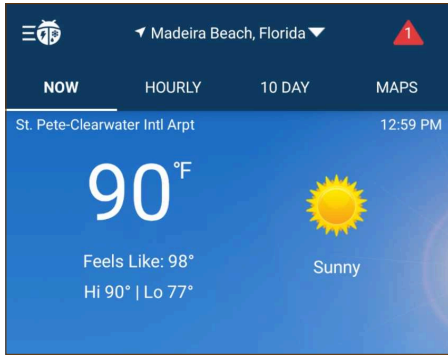
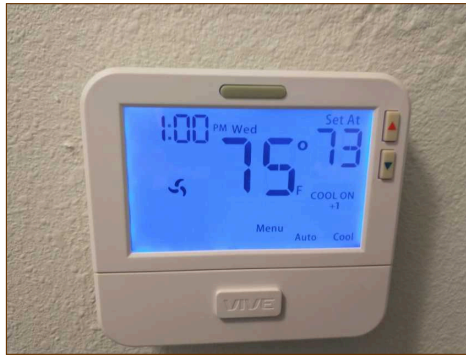
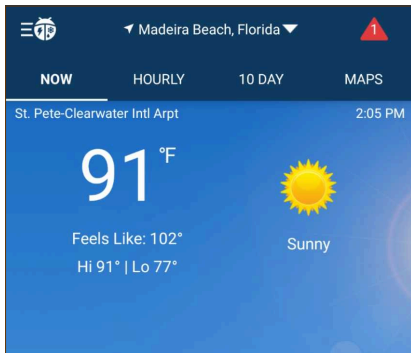
- Thermostat(s) appears to be operational. It is located in the secondary bedroom hallway.
- The thermostat never seemed to reach the target temperature and the system never shut off over the course of the inspection. This may be in part due to the lack of proper return/supply ductwork throughout the attic space and/or slight oversizing of the HVAC system(s). The system(s) may eventually bring the home to the desired temperature, however not at optimum efficiency. Elevated moisture levels are likely to be present as a result.
- Have a licensed HVAC service technician make further specialized evaluation and system design improvements as needed.

Check in, temperature dropping very slowly and system still running

Left at 74 as found, system still running

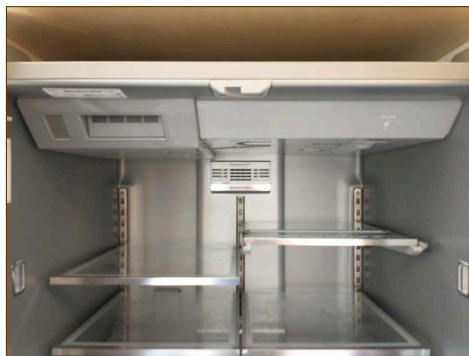
Lights not illuminating my suggest new filter is needed

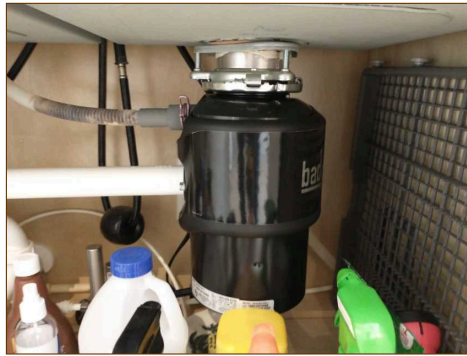
Disposal

- In-Sink-Erator
- Disposer is working fine at this time
- Wiring appears serviceable.

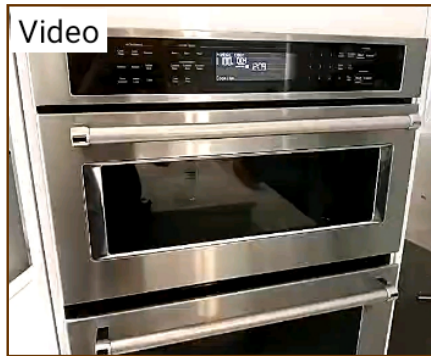
- KitchenAid.
- Microwave unit operated. No problems are suspected.

Microwave operated

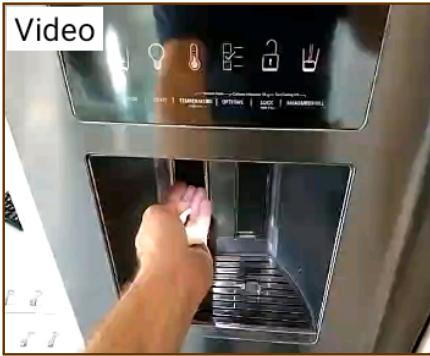
- Ice maker did not dispense.
- Make inquiry with the seller about the operation of this unit.

No ice dispensed

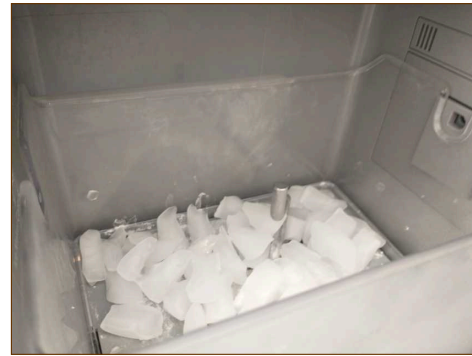
Ice in bin

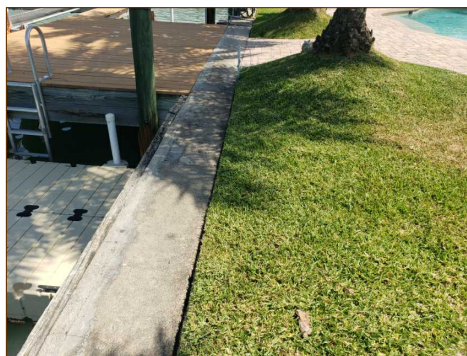
Seawall backfill is adequate
